TECHNICAL INSPECTION REPORT

OPERATION CROSSROADS. U.S.S. INDEPENDENCE (CVL 22)

TEST ABLE.

VOLUME 2 OF 4 [10]

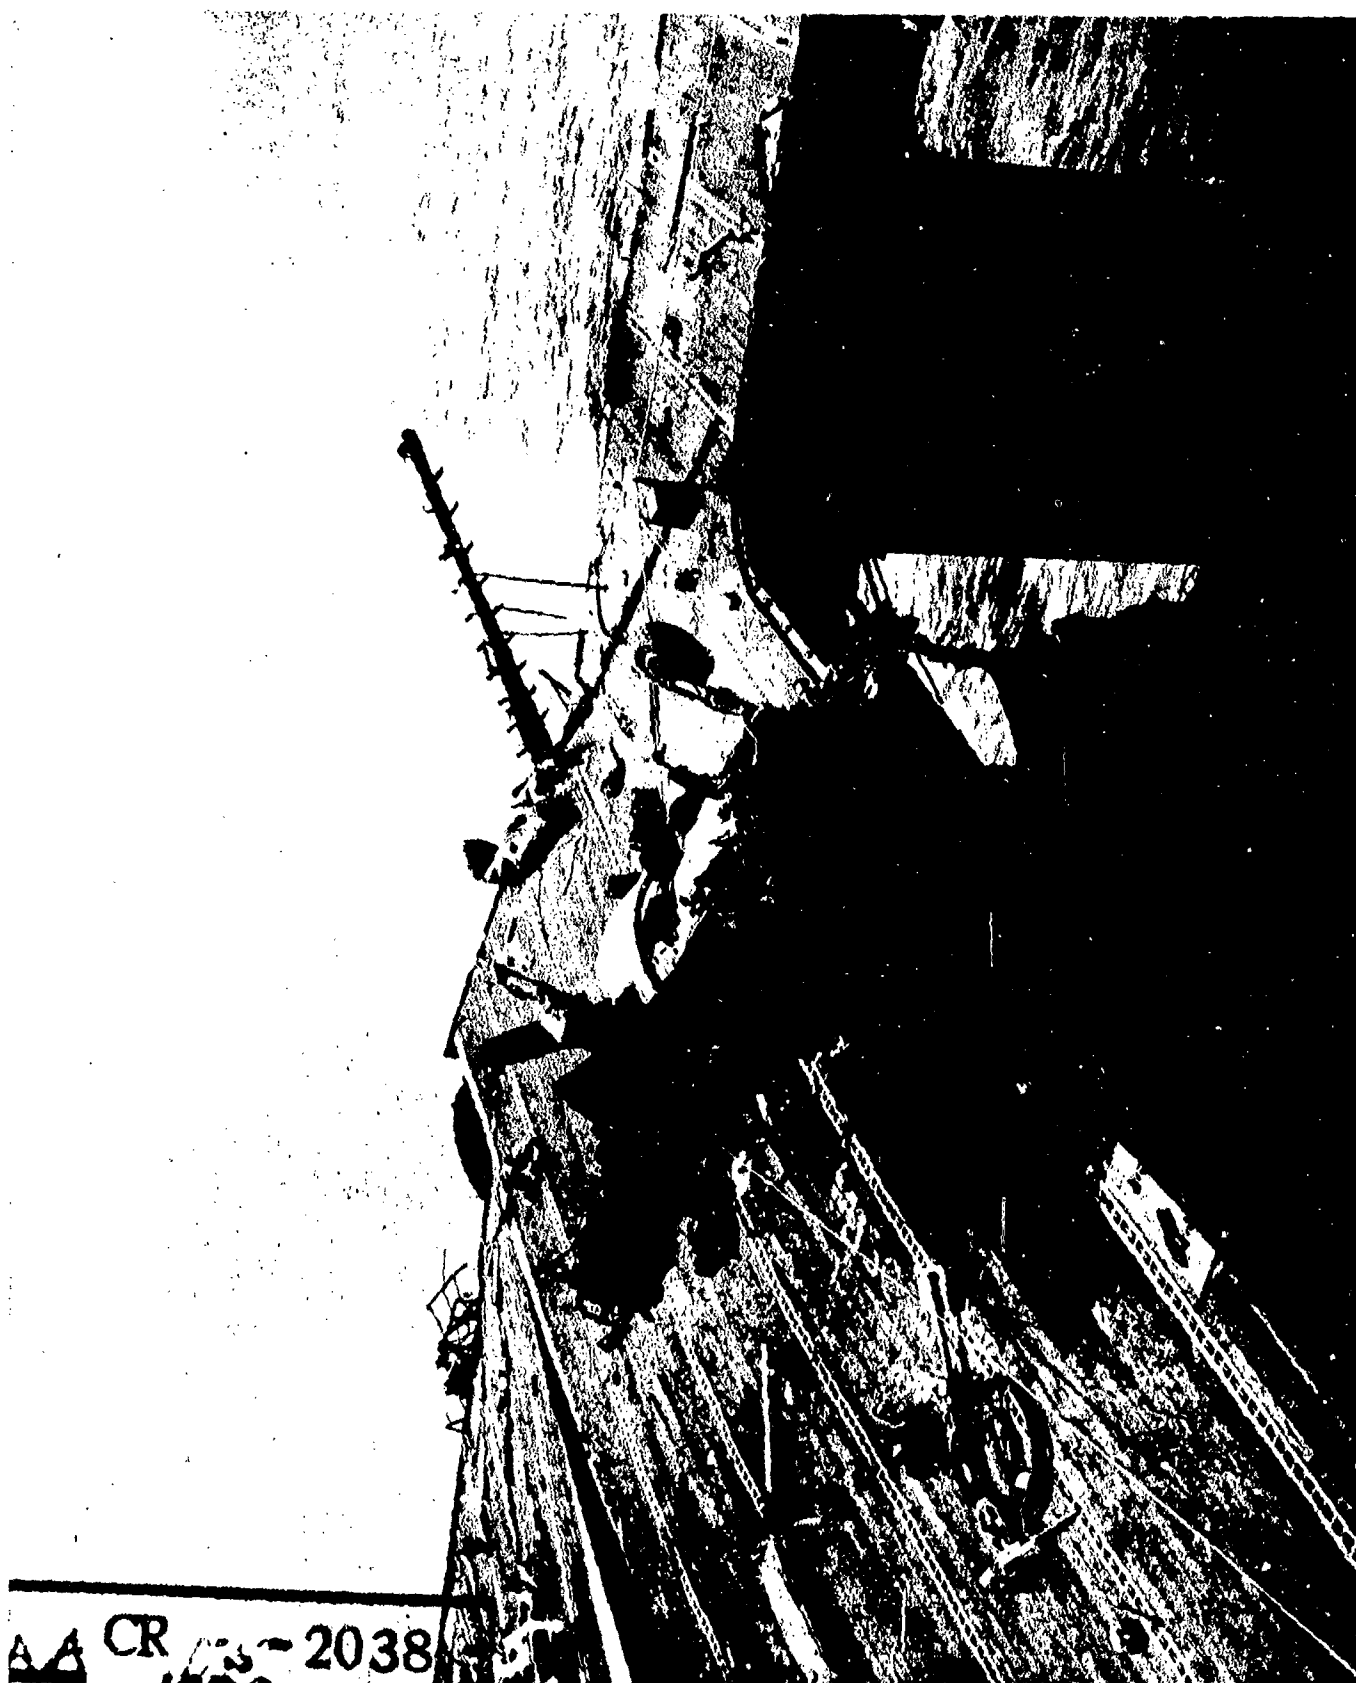
AA CR 175-2038-5

AA-CR-175-2038-5. After edge of forward elevator opening from bridge level. Note remains of only plane left on this deck after blast.

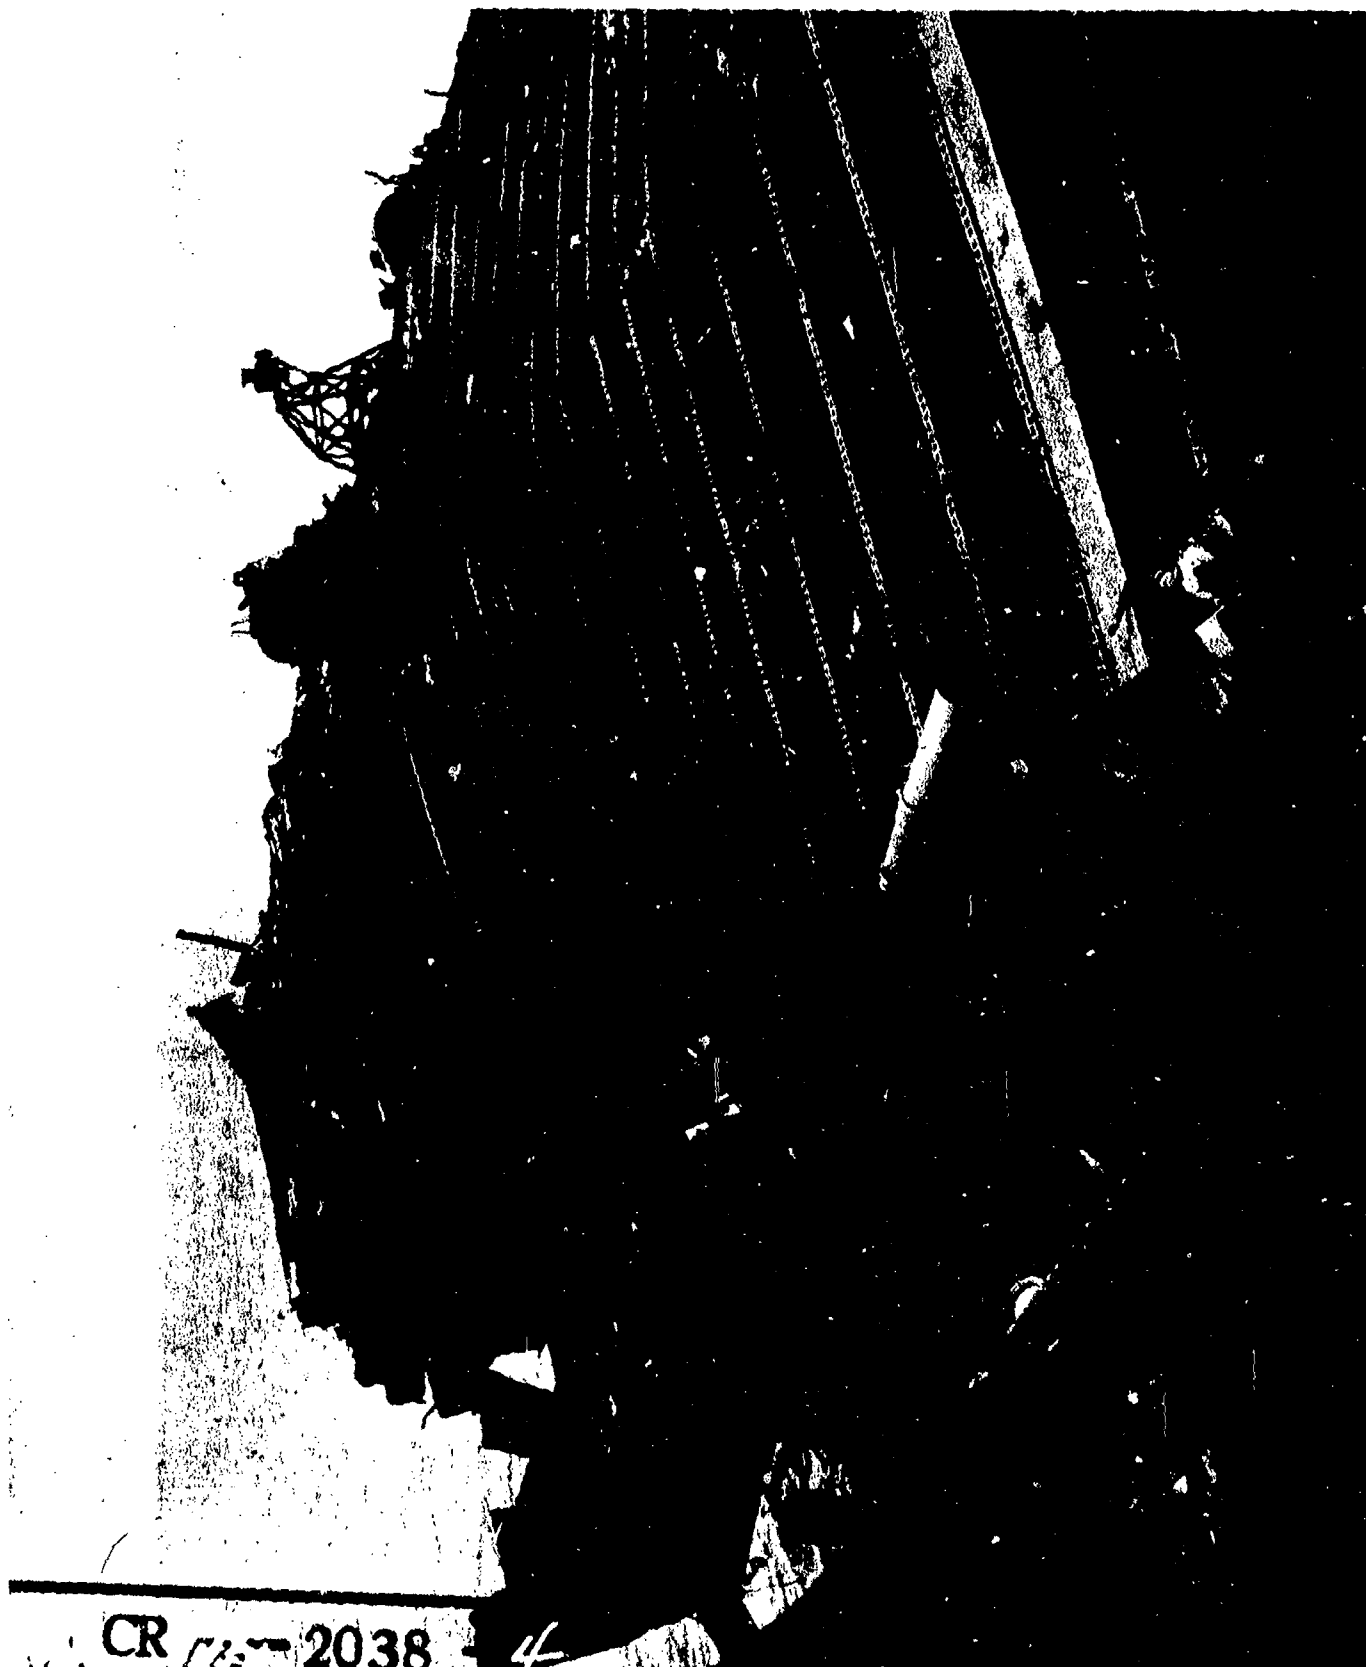
AA-CR-175-2038-4. Flight deck, looking aft from bridge level.

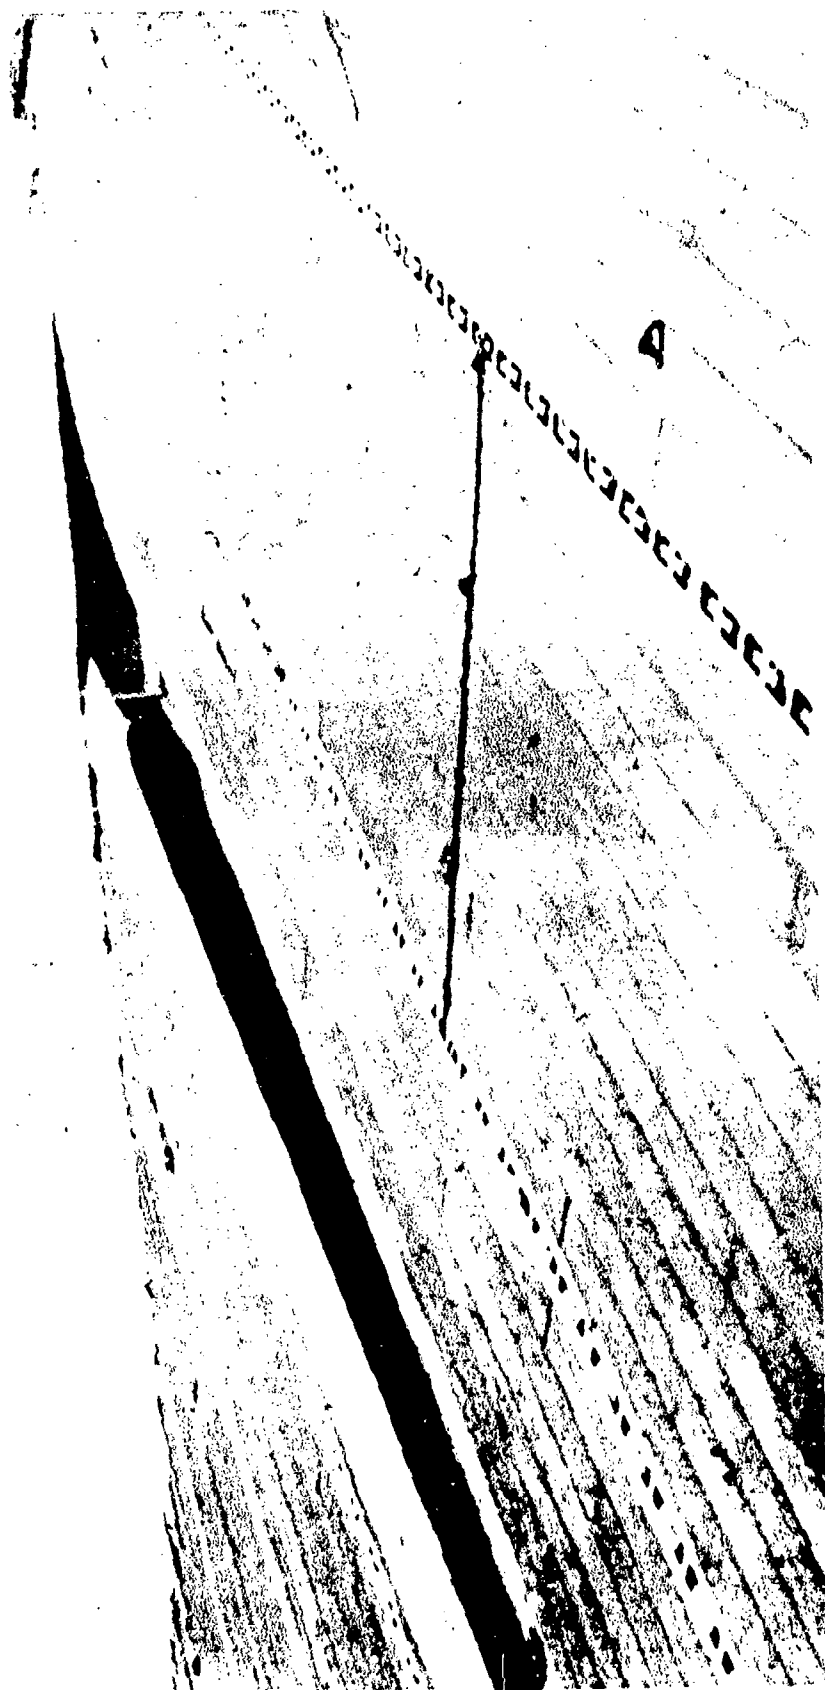
AB CR/00-2991 -

AA-CR-100-2991-3. After Baker. Flight deck. Looking aft and to port
at expansion joint at frame 63 1/2.

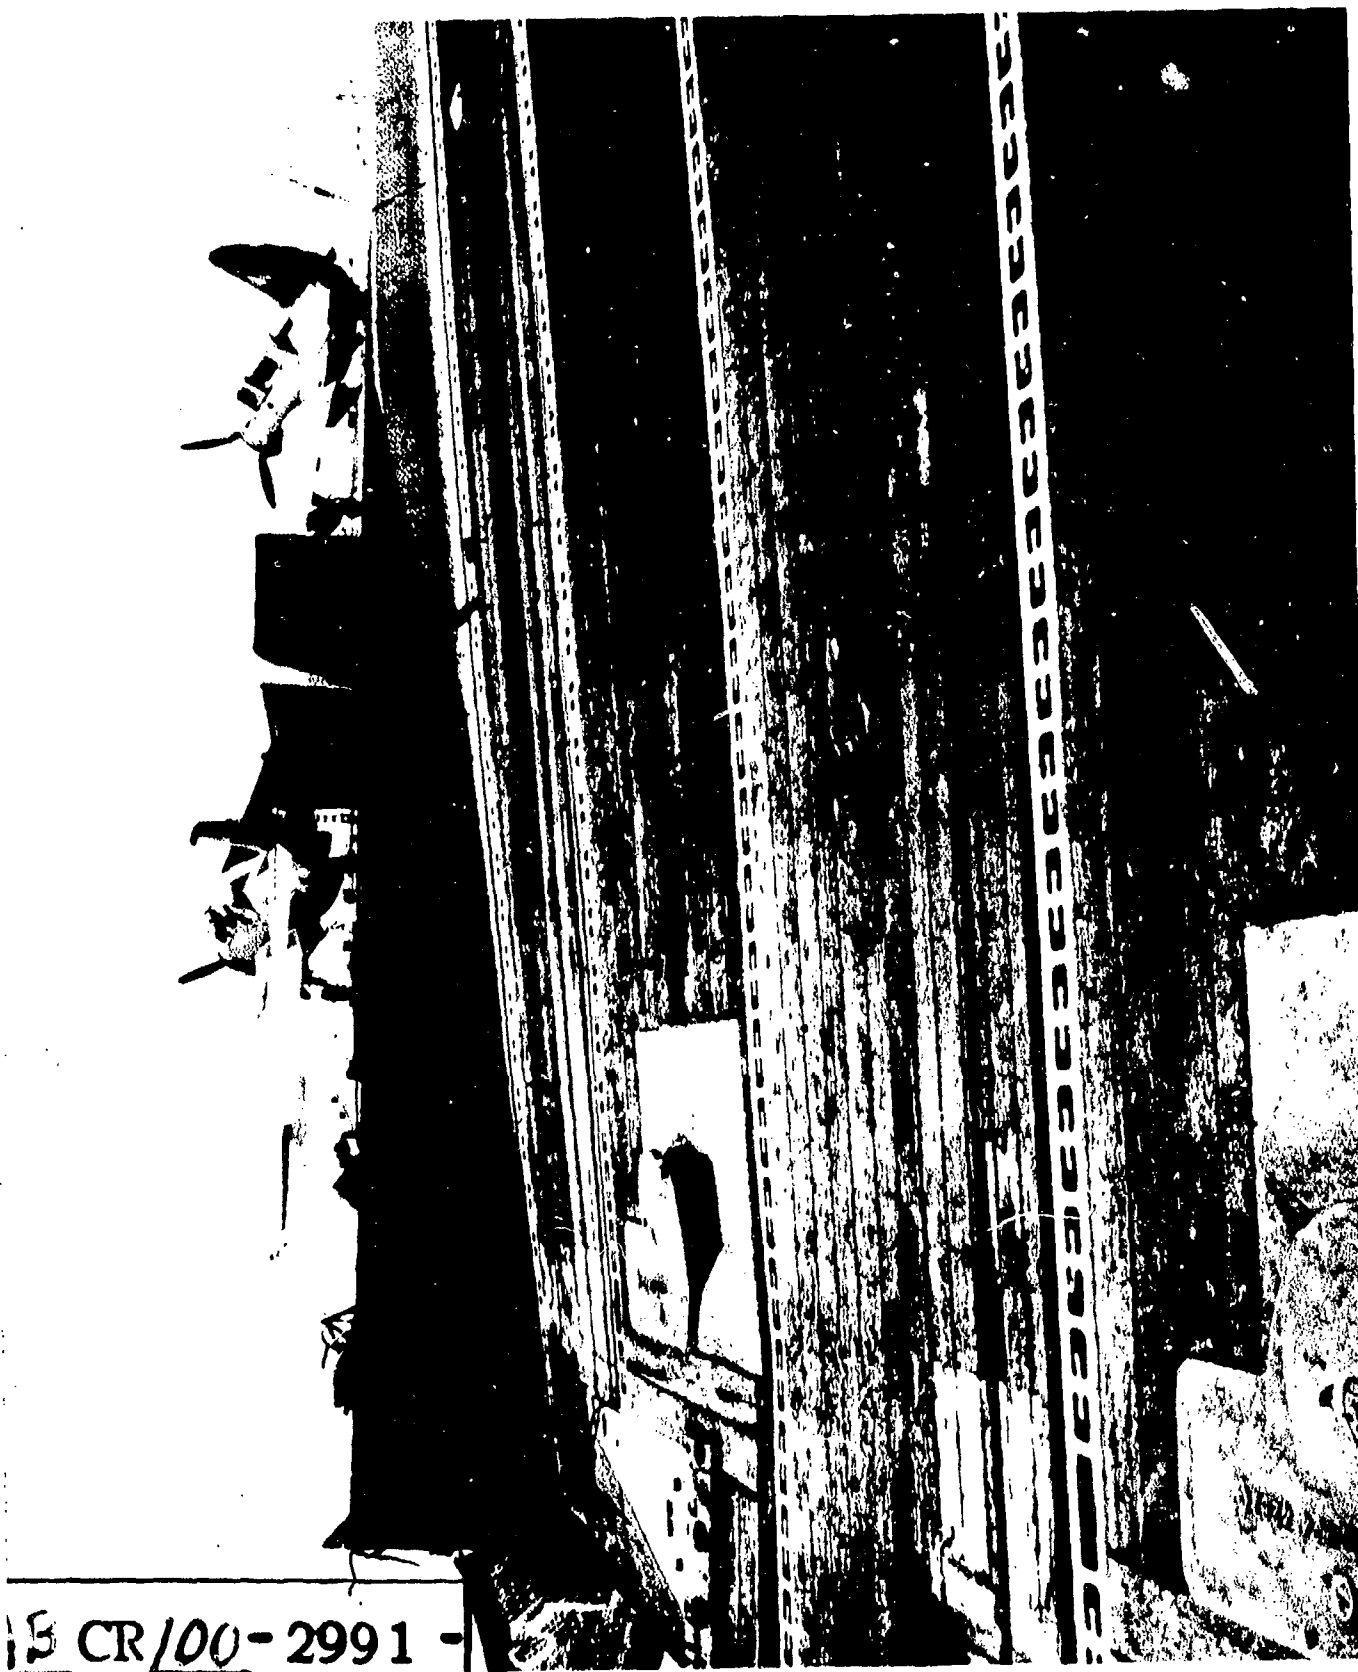
AA-CR-100-2991-5. After Baker. Flight deck. Looking forward along port side from frame 71.

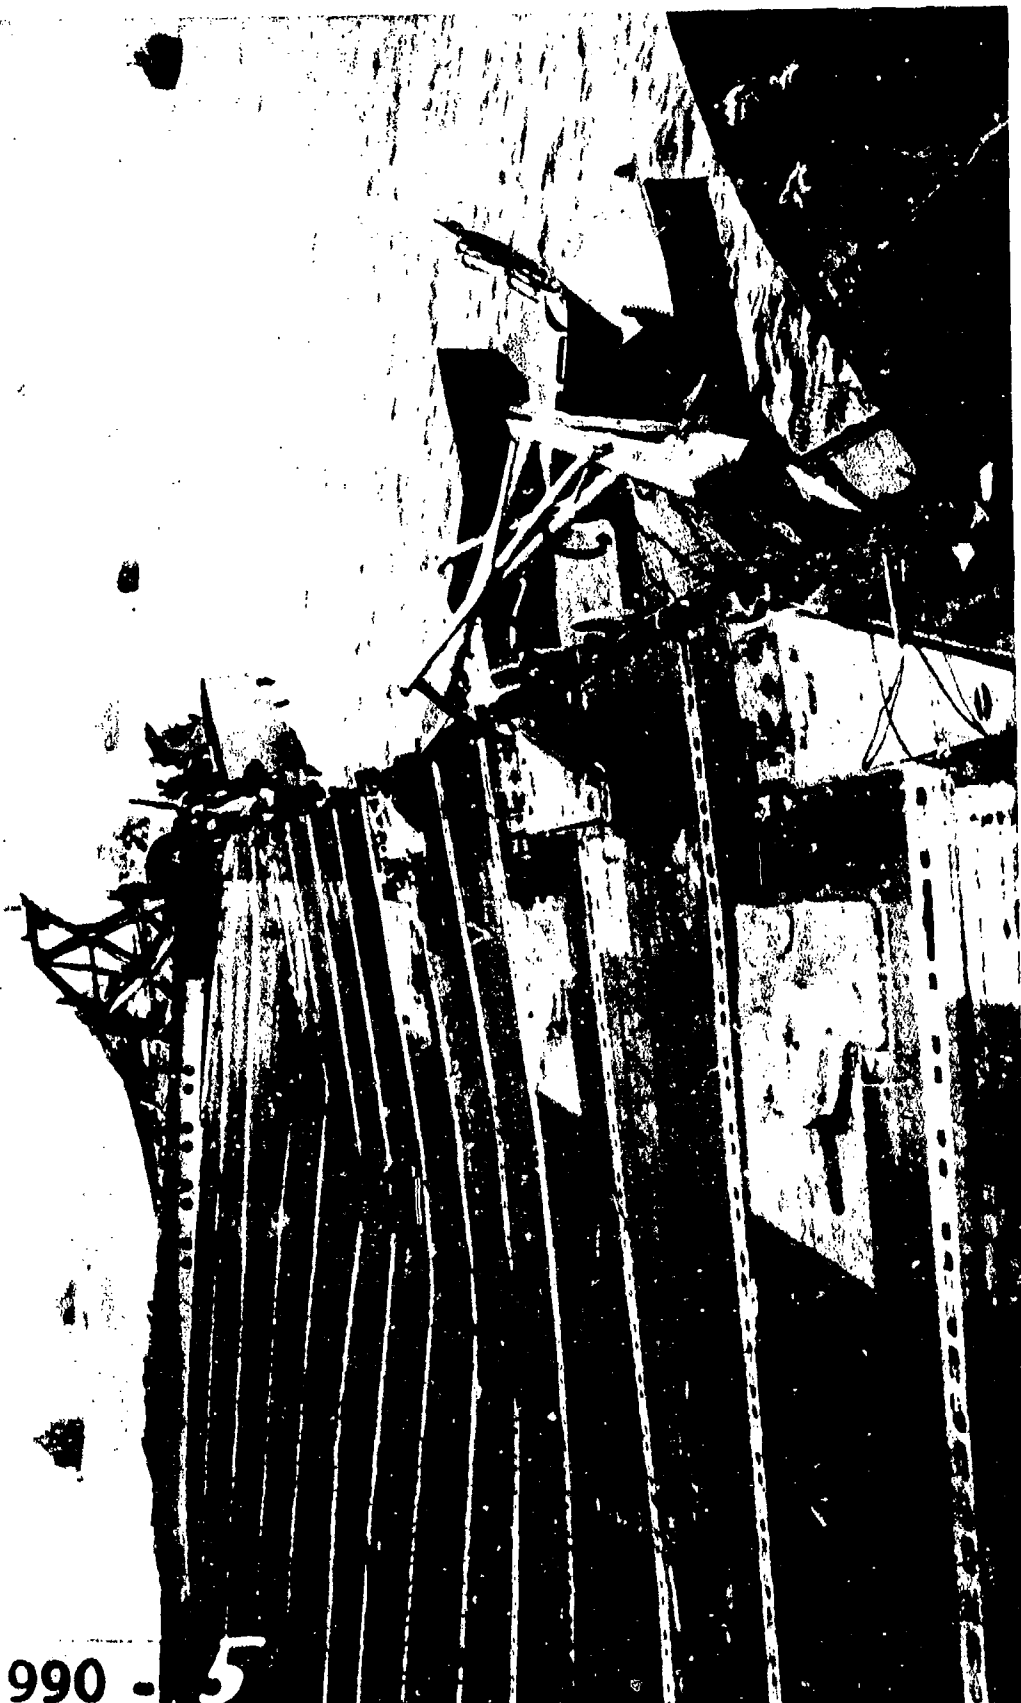
4A CR234-1990 - 5

AA-CR-234-1990-5. Flight deck, port side looking aft from frame 63 1/2.

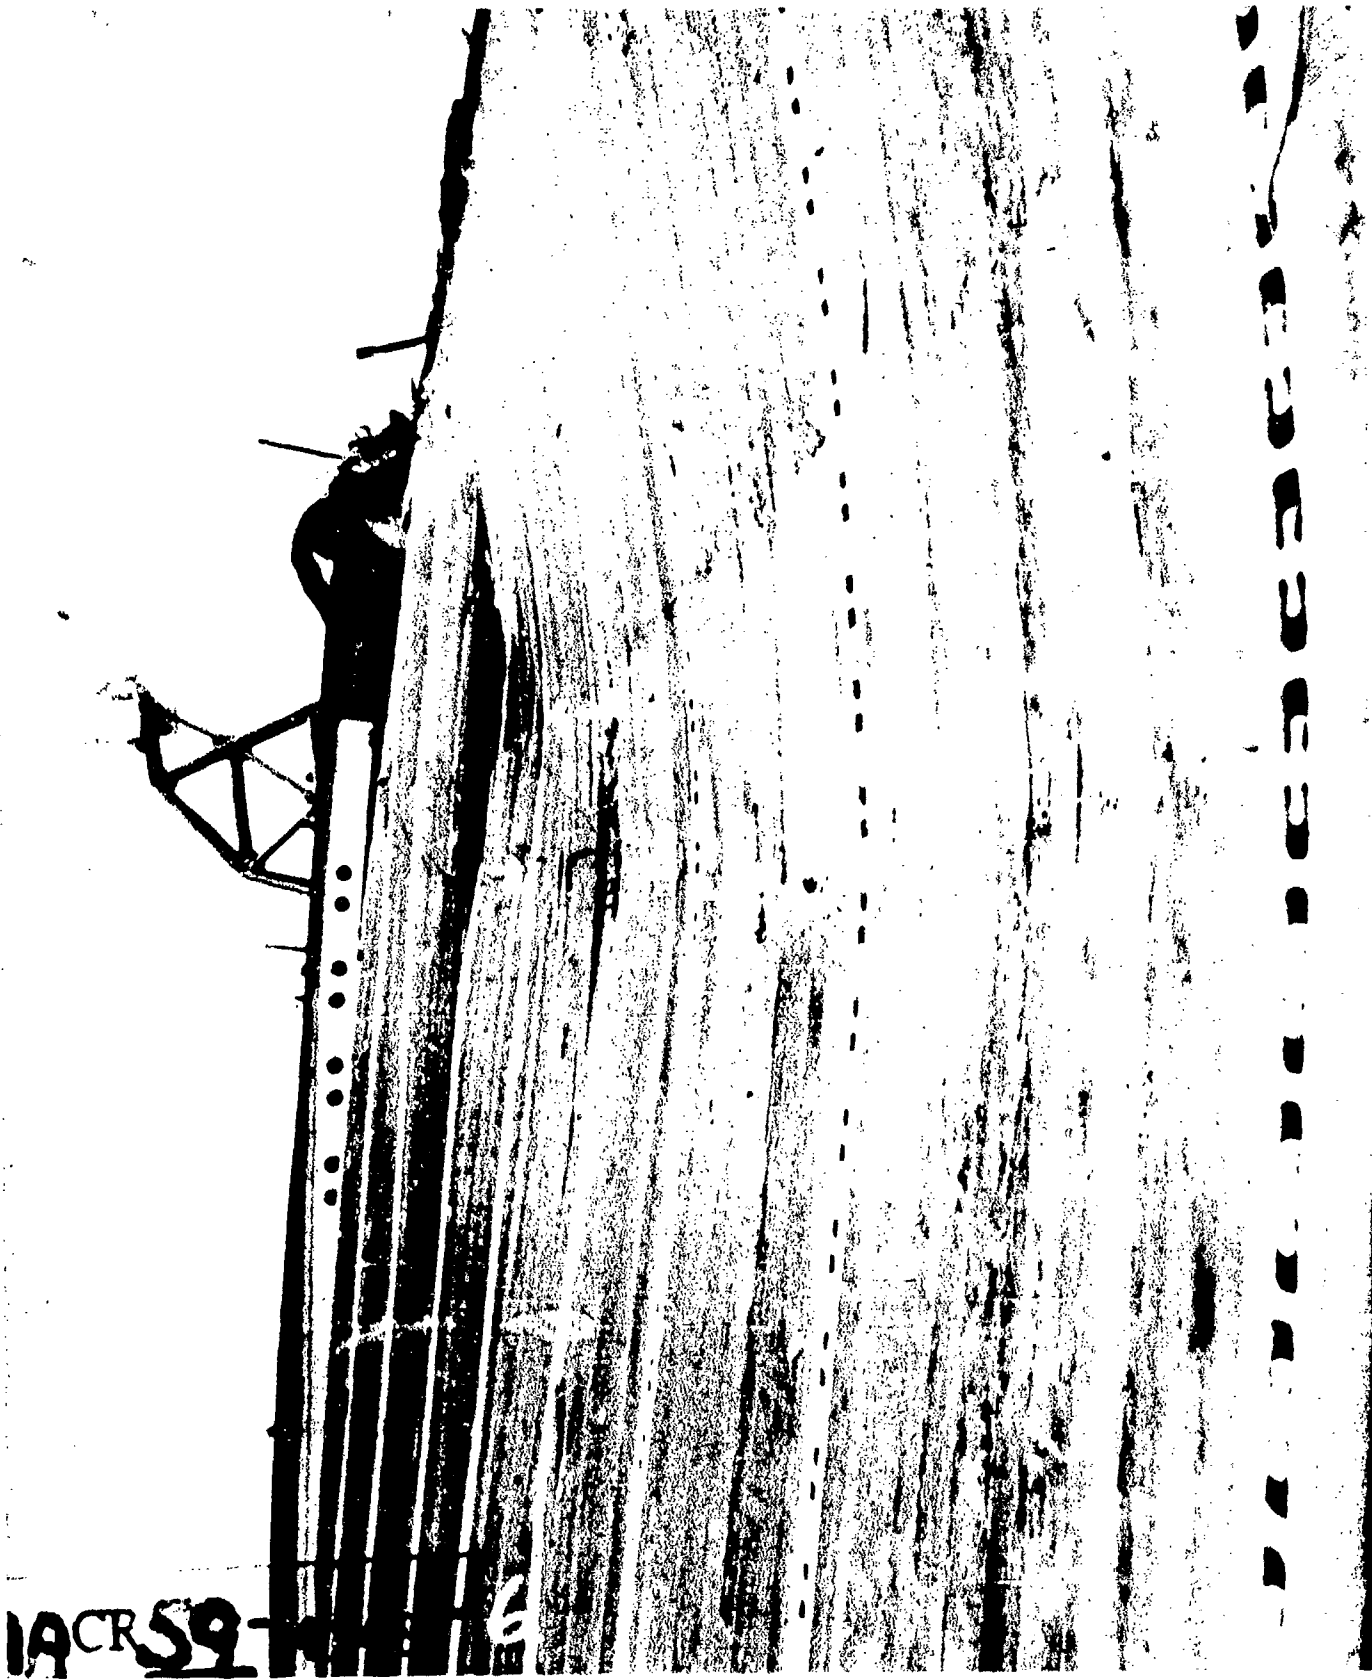
AA-CR-59-4148-6. Flight deck, port side, looking aft at frame 75. Note that there appear to be two longitudinal breaks in deck approximately parallel to deck edge.

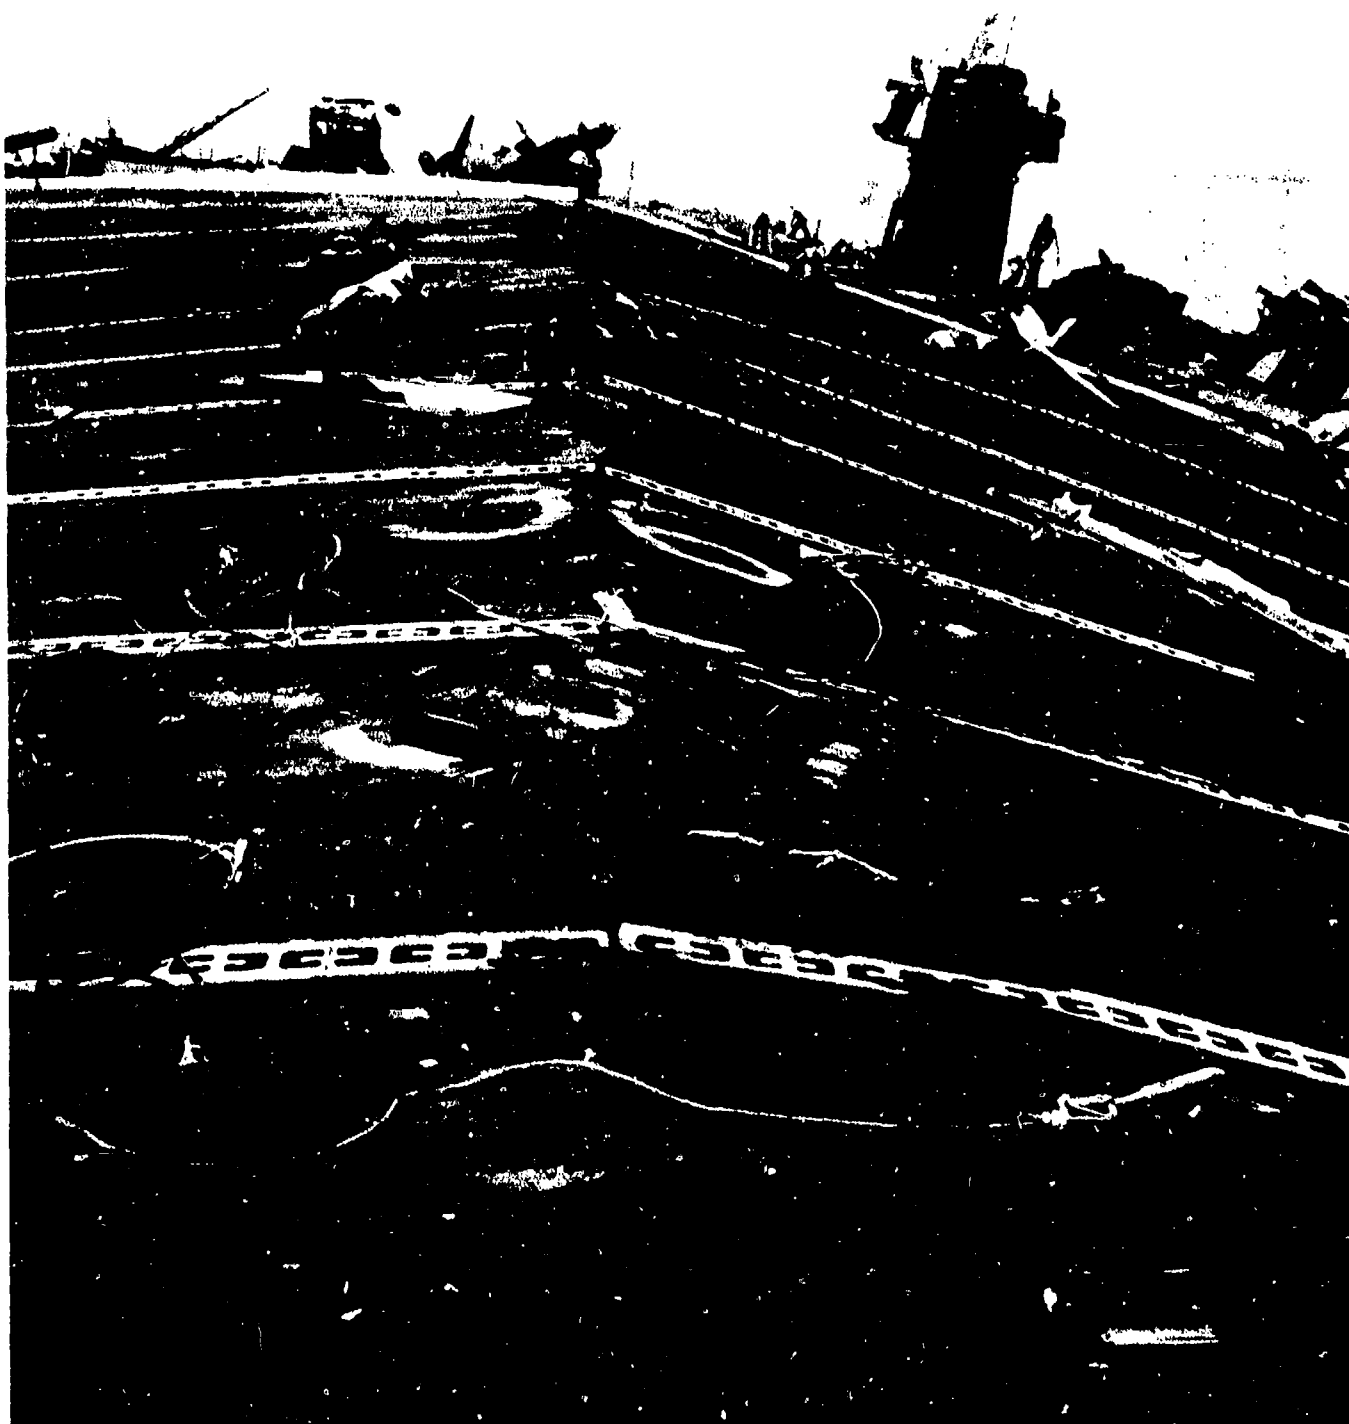
AA-CR-175-2041-3. Flight deck looking forward along centerline between forward and after elevators, showing damage resulting from upward movement of flight deck.

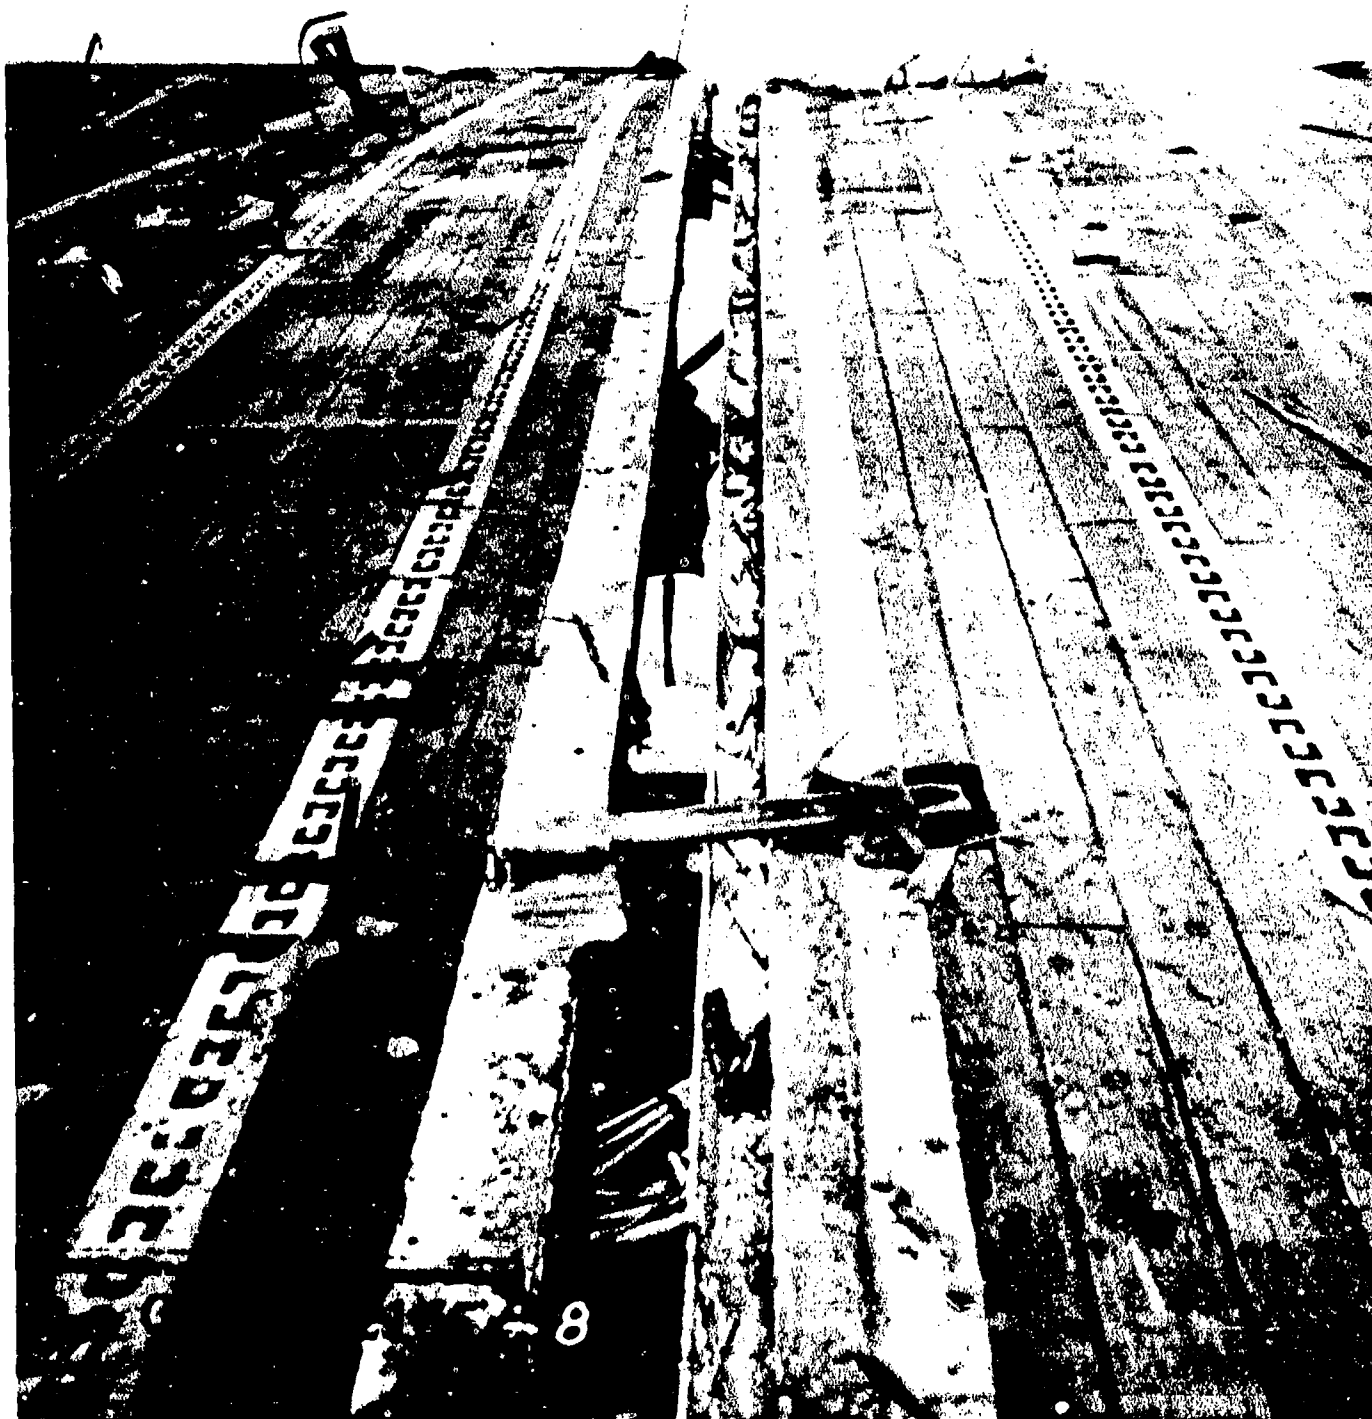
AA-CR-59-2165-8. Flight deck expansion joint frame 111 1/2. Looking to port. Joint open 5 1/2" starboard and 21" (far) port side.

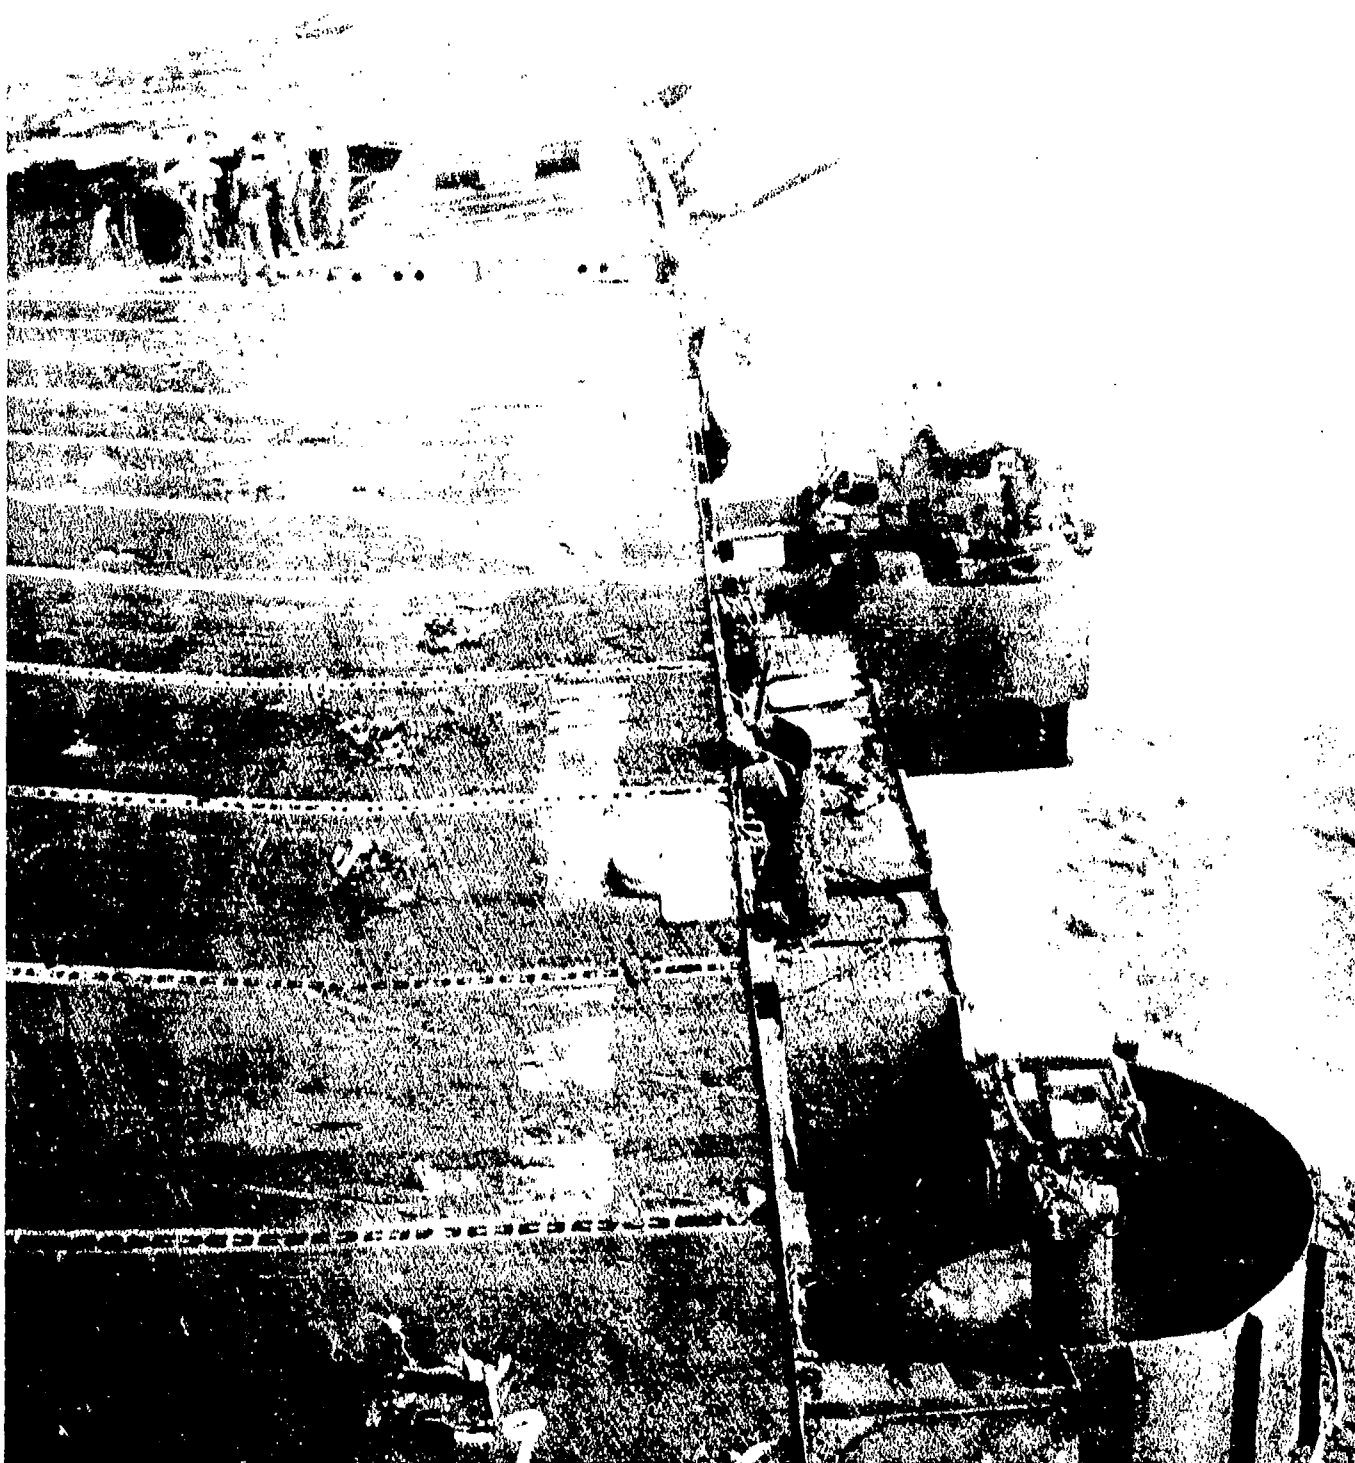
AA-CR-59-2165-9. Flight deck. Looking aft along port side from about frame 98. Note void in aft corner of flight deck.

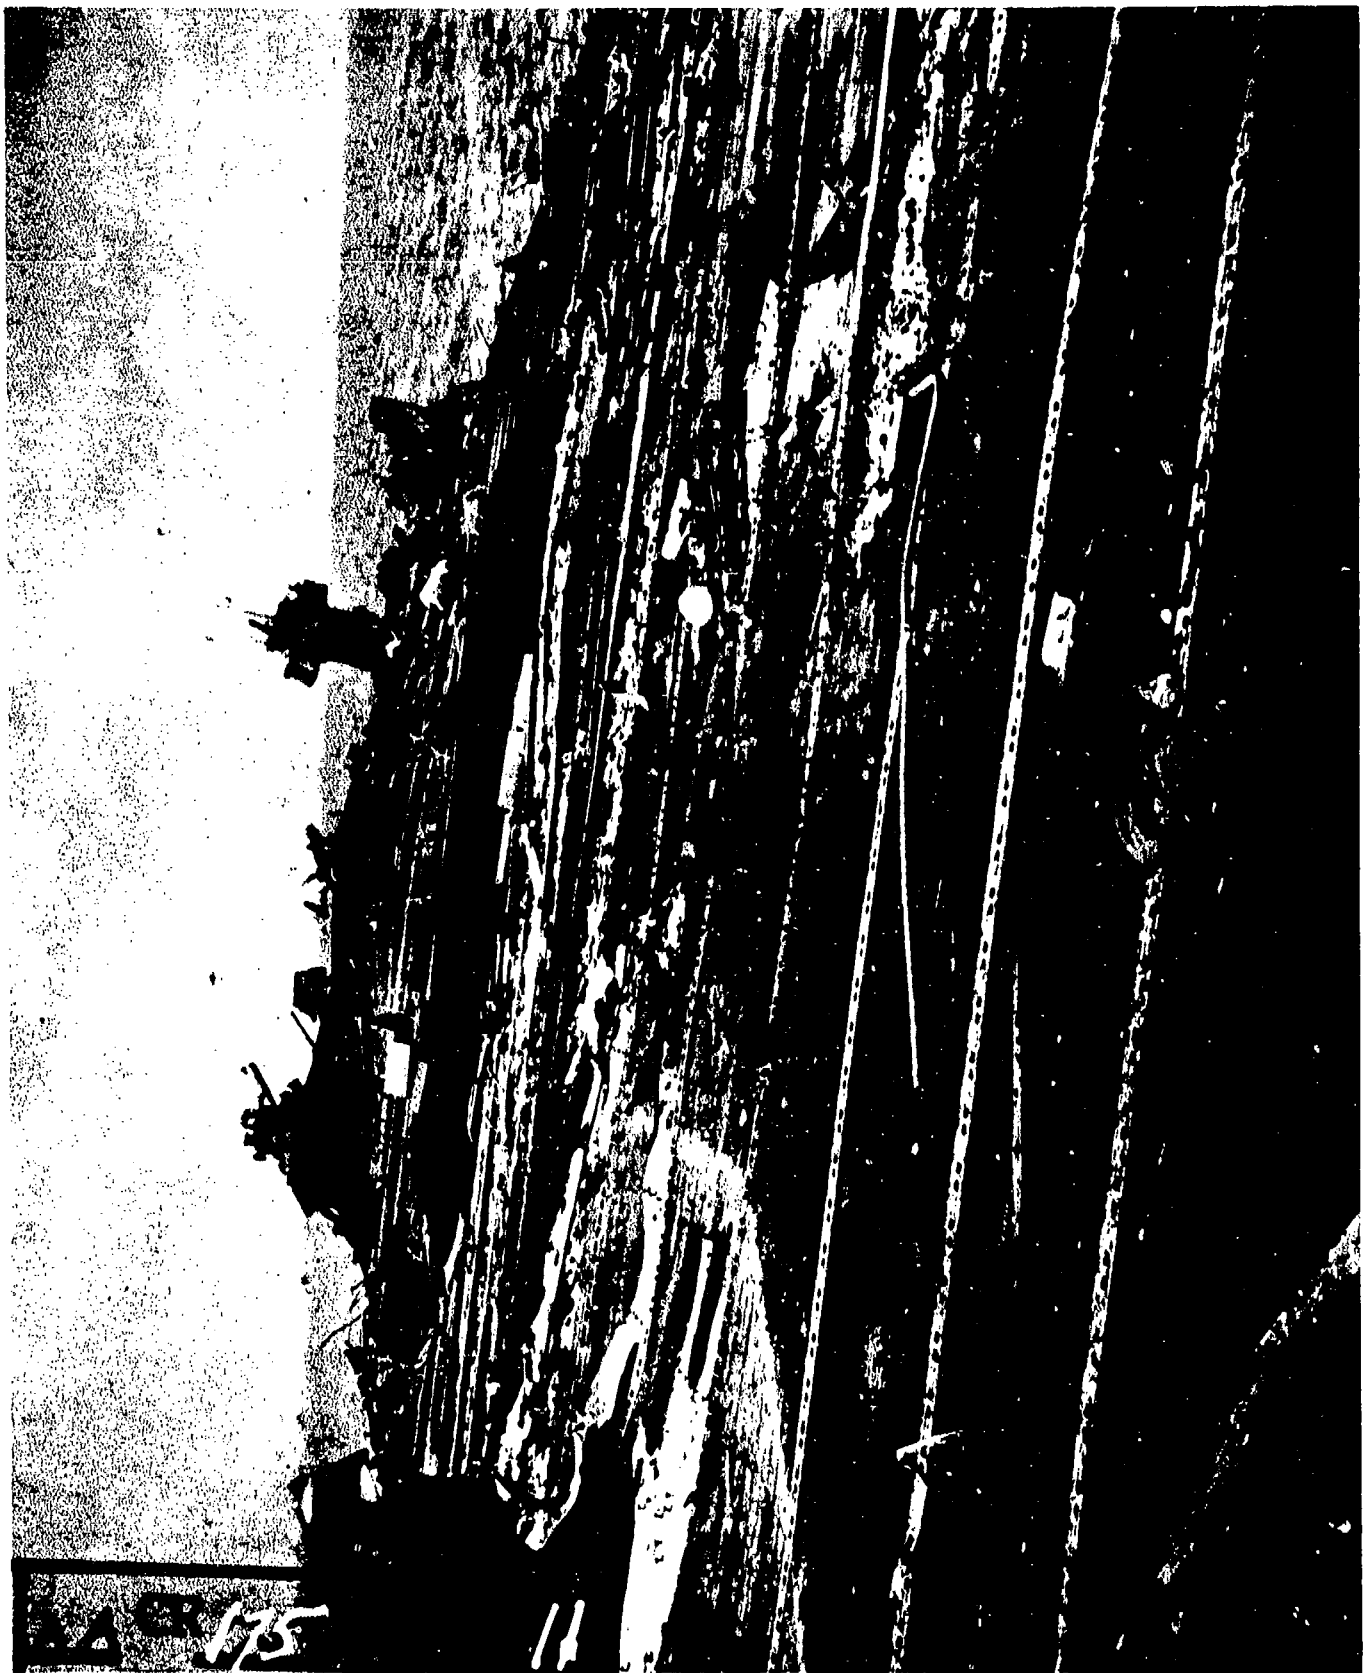
AA-CR-175-2038-11. Flight deck. Looking forward along centerline.

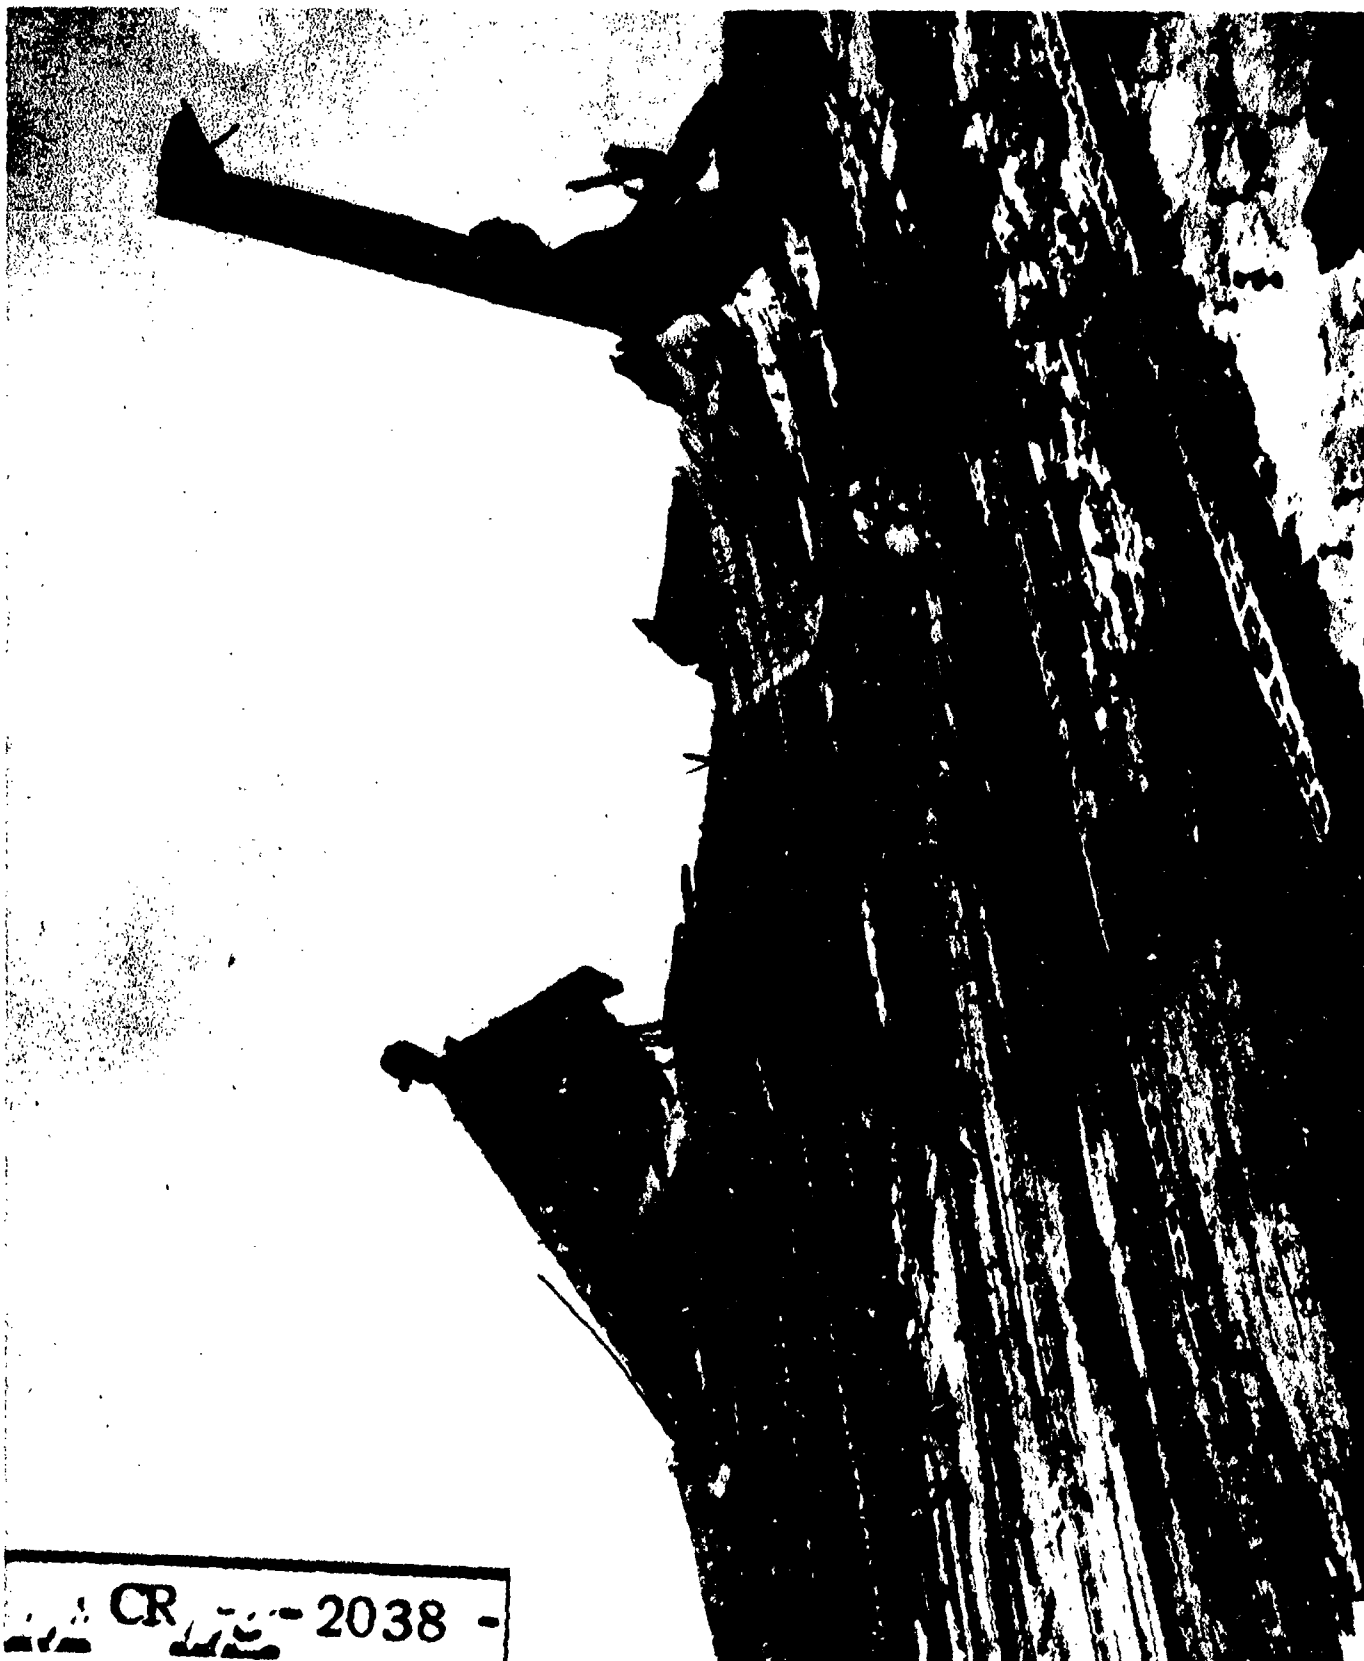
AA-CR-175-2038-6. After port corner of flight deck showing after edge bent up and deformation of beam at frame 138.
